ENGINEERING ASSESSMENT AND DESIGN REPORT

43 Albert Street, Hamilton

PROJECT NO. 16537

TITUS
CONSULTING ENGINEERS

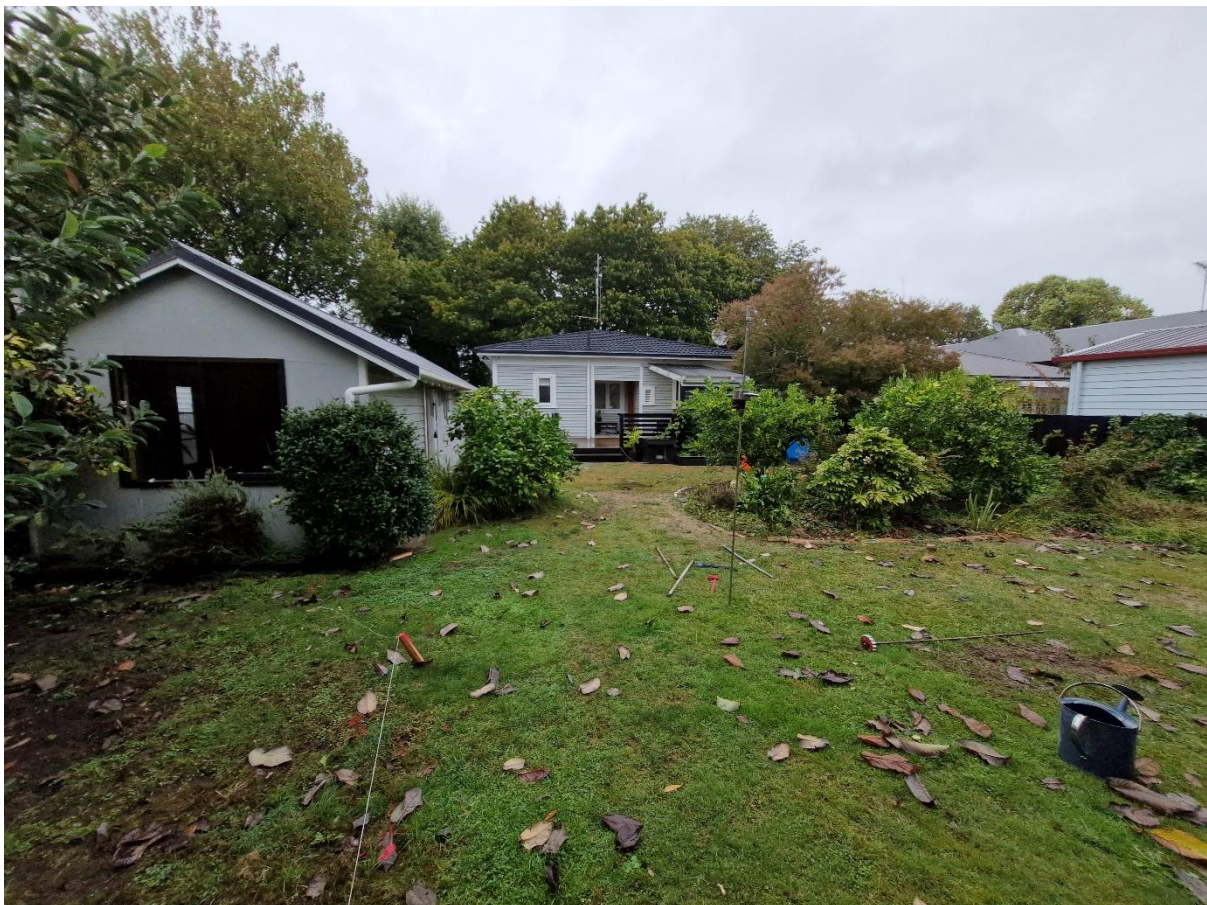
Figure 1: Site Photo

The site is located approximately 2km to the southeast of Hamilton centre. The site is currently a residential lot. The site is bordered by other residential lots with Albert Street to the south. The area near the proposed foundation is flat. No retaining walls were noted on the site.

There are no significant water courses or gullies on the site. The proposed works will not influence the existing stormwater overland flow path/s (OLFP).

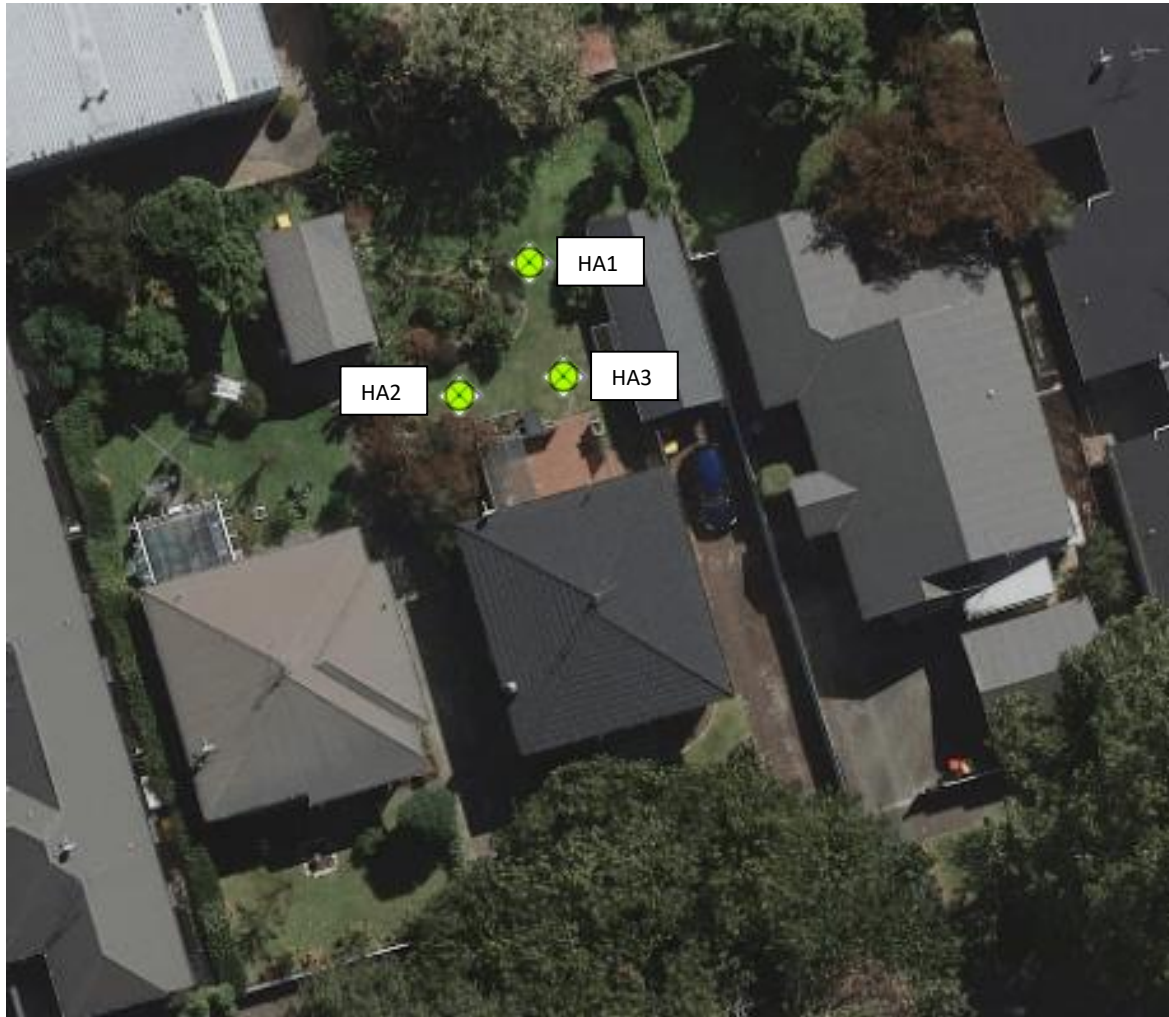
APPENDIX A – Test Locations

Test locations are shown in Appendix A.

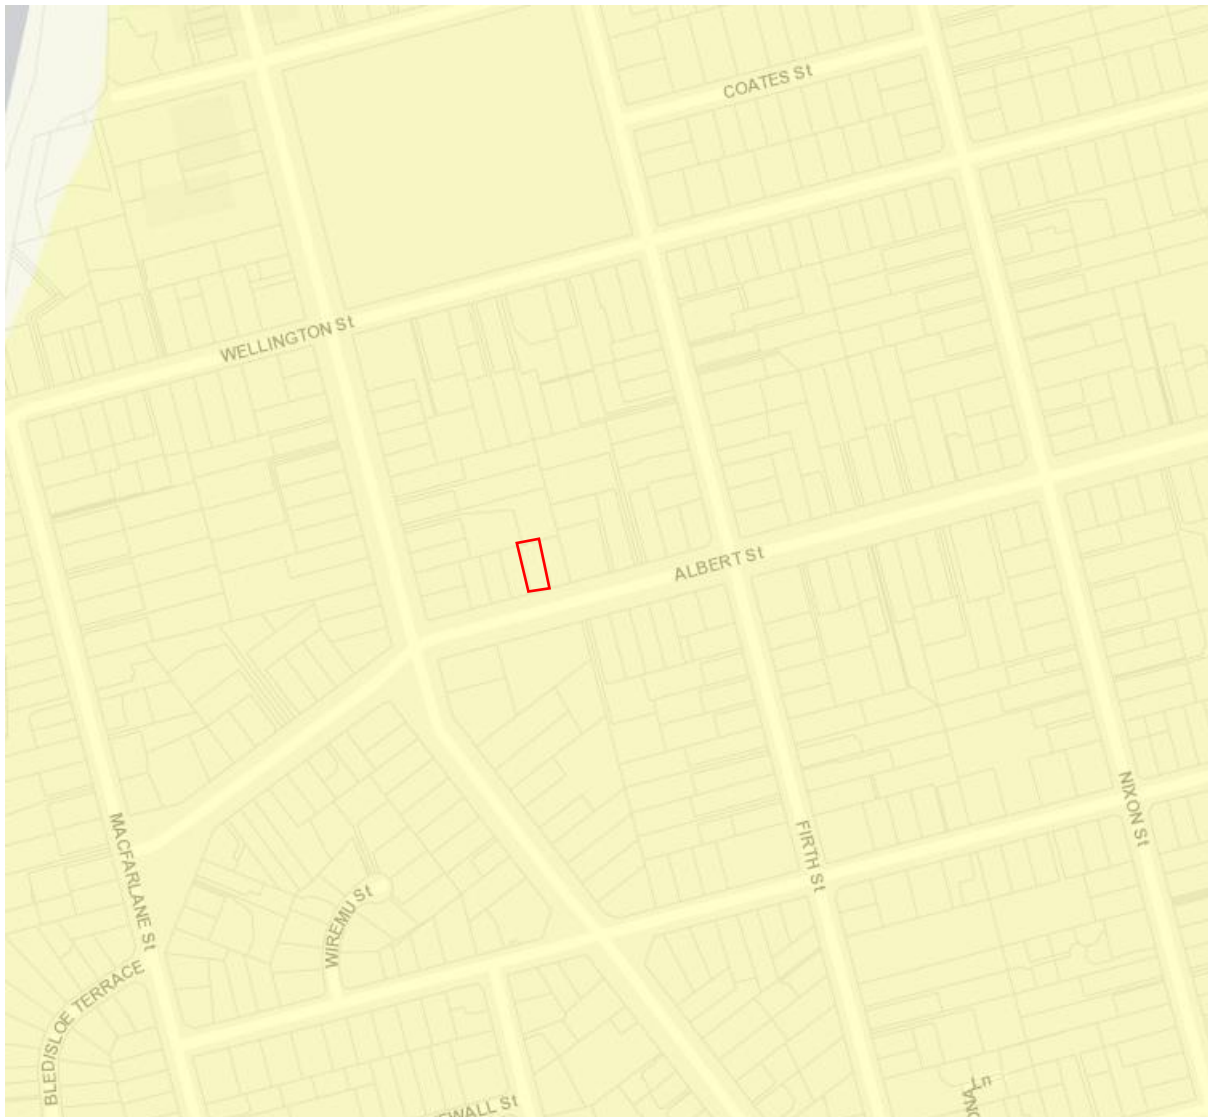
APPENDIX D – Underlying Geology

Name: OIS3-OIS2 (Late Pleistocene) river deposits (Hinuera Formation)

Simple name: Late Pleistocene river deposits

According to GNS Science (GNS Science, 2018), the underlying geological formation of this site is OIS3-OIS2 (Late Pleistocene) river deposits (Hinuera Formation), as shown in Appendix D. This was deposited between 0.012ma and 0.027ma. This formation is described as "Cross-bedded pumice sand, silt and gravel with interbedded peat."
